Service bulletin

C
223

SEAT MODIFICATION

SPRITE

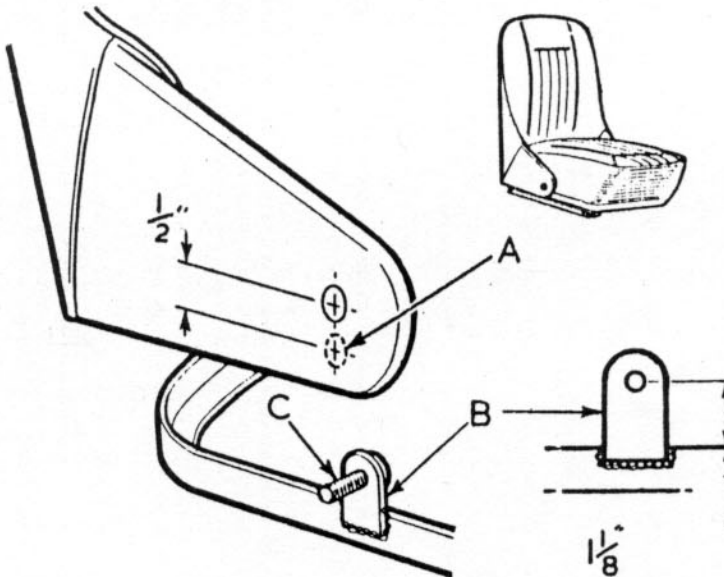
It is possible that tall owners may find the seating position more comfortable if the angle of the seat back is altered.

1. Remove seat back and drill an additional hole $21/64$ " dia., each side, as shown at 'A'.

Refit seat back using new holes.

2. (a) Dismantle seat and remove frame from floor.
(b) Remove bracket 'B' from frame with a cold chisel.
(c) Make a new bracket from 10 SWG strip, $\frac{1}{2}$ " longer than existing bracket.
(d) Transfer welded bolt 'C' to new bracket.
(e) Weld new bracket to seat frame so that centre-line of bolt is $1\frac{1}{8}$ " above frame.
(f) Fit frame to car and reassemble seat back.
